September 19, 2005
Job #02505.1

RE: GEOLOGIC REPORT UPDATE
Proposed Residential Subdivision
2492 D Street
Hayward, California

August 21, 2002
Job #02505.1

RE: GEOLOGIC INVESTIGATION
Proposed Subdivision
2492 D Street
Hayward, California

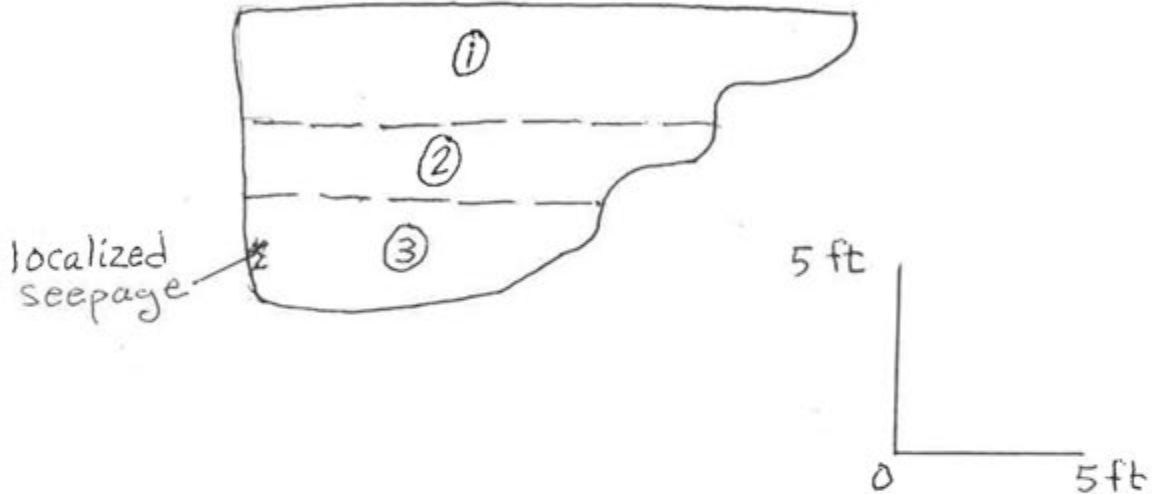
TP-1

perhaps bedding trending North 20 degrees west and dipping vertically were measured in Test Pit TP-7. Localized ground water seepage occurred at a depth of about 6 feet in Test Pit TP-1.

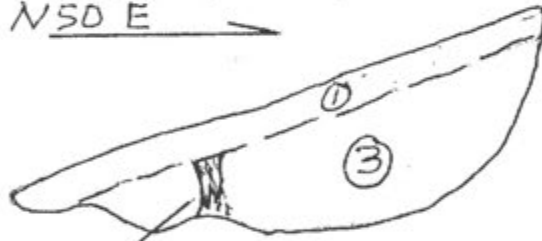
TP-2

Bedding: N 40 W, vertical
(clay seams)

- ① Gray-brown silty Clay
- ② Brown silty clay, more clayey with rock fragments
- ③ Brown, fractured, massive, soft to hard, fine-grained weathered sandstone

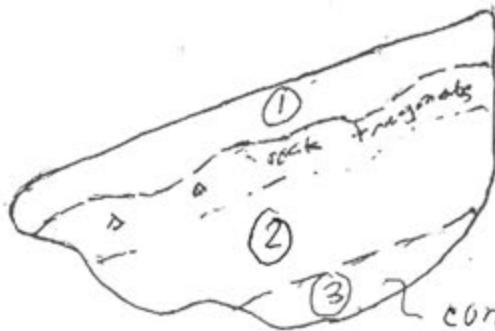
TP-4

contains siltstone and shale, but massive, no bedding observed

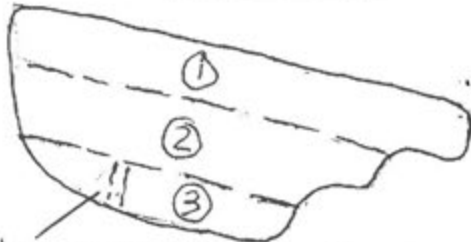
TP-7

Joints: N20W, vertical or Beds:
